# Manhole Inspection Summary

Manhole # S06CC2015MH

**Location** Address: **6923 FIELDCREST RD**

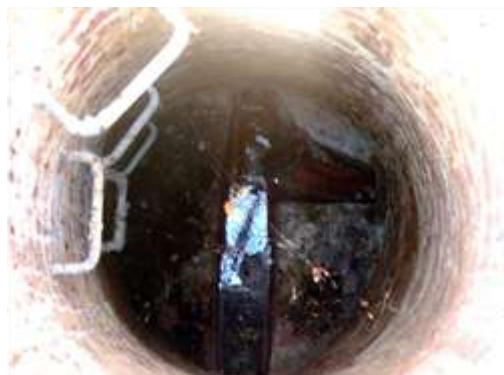
Top View

Evidence of surcharge - Bench debris.  
Channel debris.

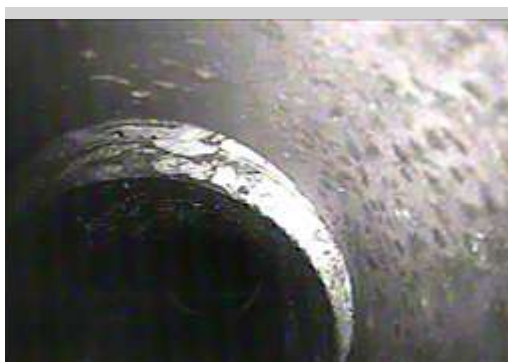
Inside the I3

Offset joint.

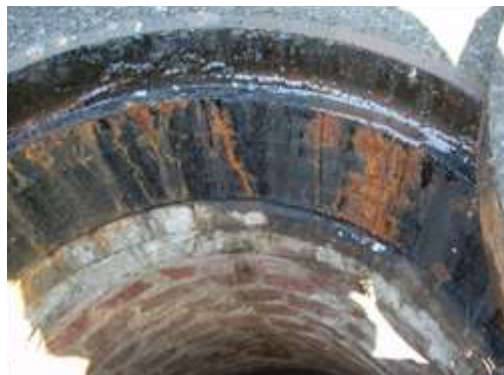
Defect

Adjustment and Barrel infiltration.

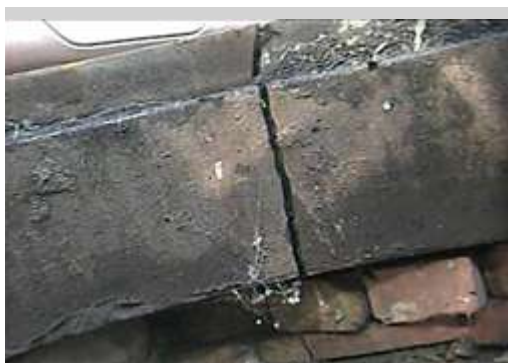
Defect

Cracked frame. Frame leaks. Adjustment deterioration, loose brick and infiltration.

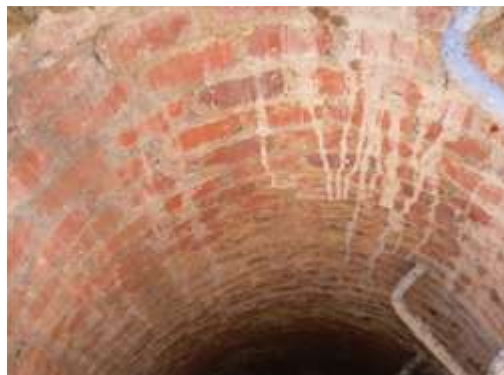
Defect

Adjustment and Barrel infiltration.

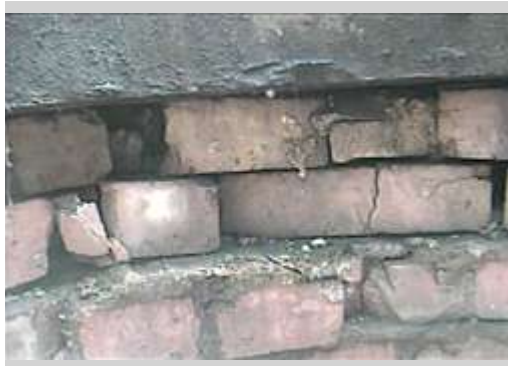
### Defect

Frame leaks. Adjustment deterioration, loose brick, cracks and infiltration.

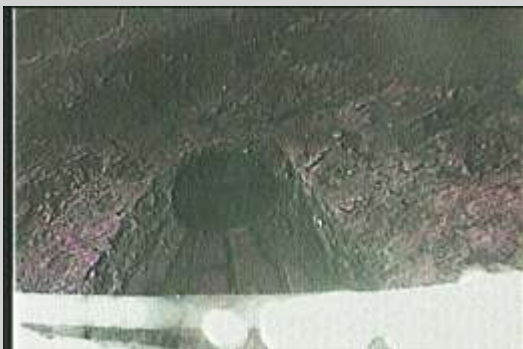
### 6 in. Circular Gravity Sewer Pipe In @ 3 O'Clock

Barrel deterioration and infiltration. Channel deterioration.

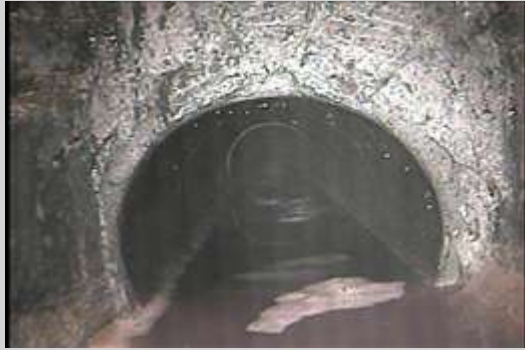
8 in. Circular Gravity Sewer

Deposits: ☐ None ☐ Mud ☐ Sludge ☒ **Debris** ☐ Grease

Silt Depth: **0.5** (in.)

Deposits Extent: **Light**
